Determination of NRHP Eligibility for Buildings 28414, 32100, 33800, 36300, and 36302 at Fort Gordon, Georgia

Includes a Criteria Consideration G Evaluation of the 1988 Barracks Complex

Adam D. Smith and Sunny E. Adams

January 2017

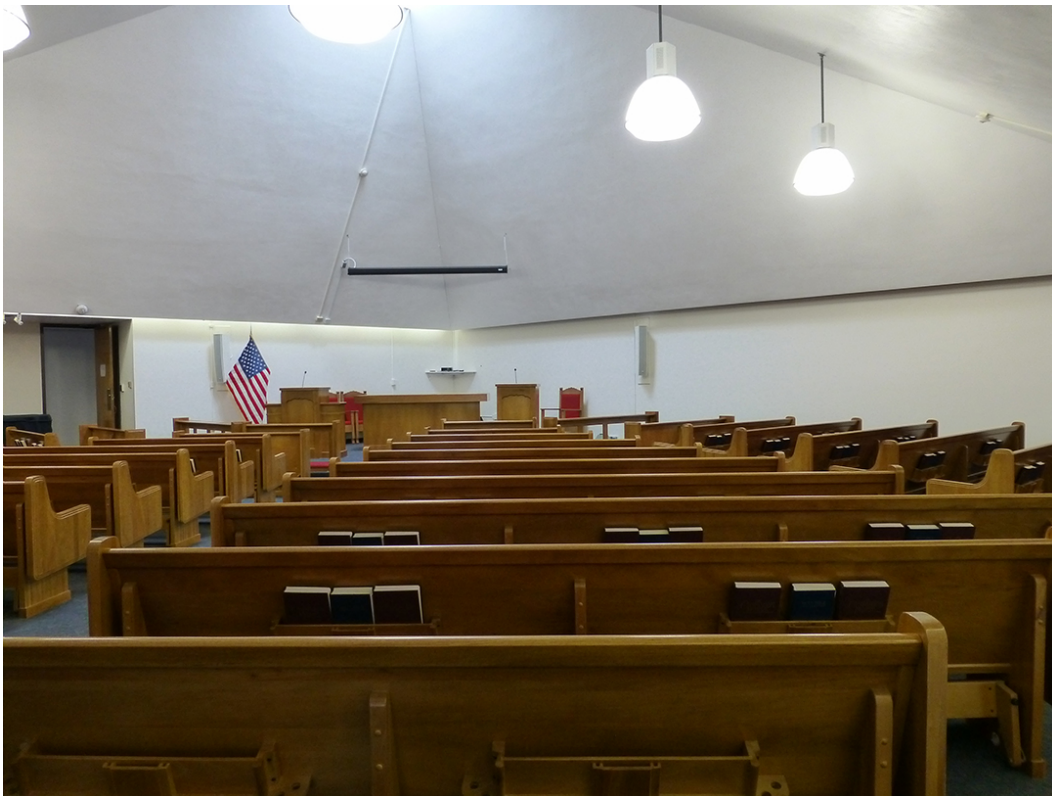
Figure 34. One of the replacement light fixtures in the nave of Building 28414 at Fort Gordon, GA (ERDC-CERL, 2015).

skylight at its point. The ceiling is plaster with replacement hanging-pendent light fixtures (Figure 34). The flooring is carpet. The original pews are of blonde wood with red upholstery (Figure 35).

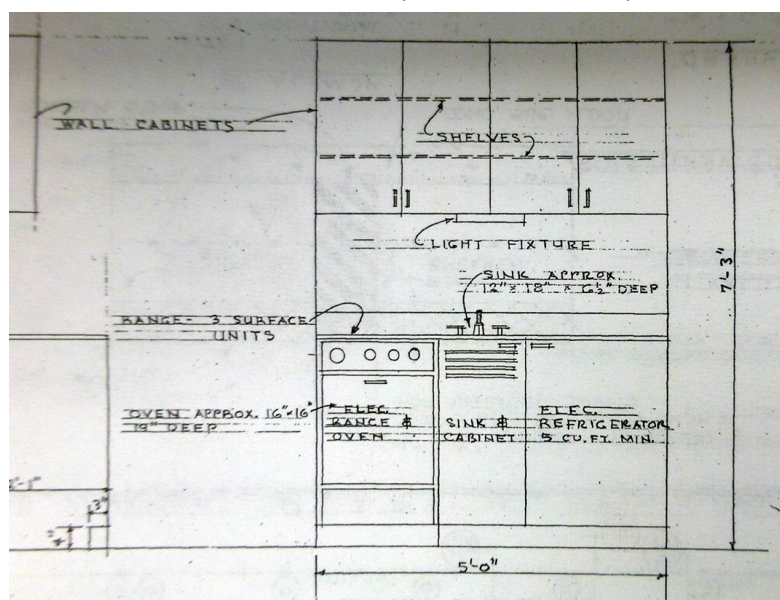
Figure 82. Original cabinets have been removed and replaced in the laundry room on the second floor of Building 33800 at Fort Gordon, GA (ERDC-CERL, 2016).

The original plan for the enlisted women's barracks had a laundry room with metal cabinets on each floor (Figure 81). The second-floor space was divided into office space, and the metal cabinets were replaced with wood cabinets (Figure 82).

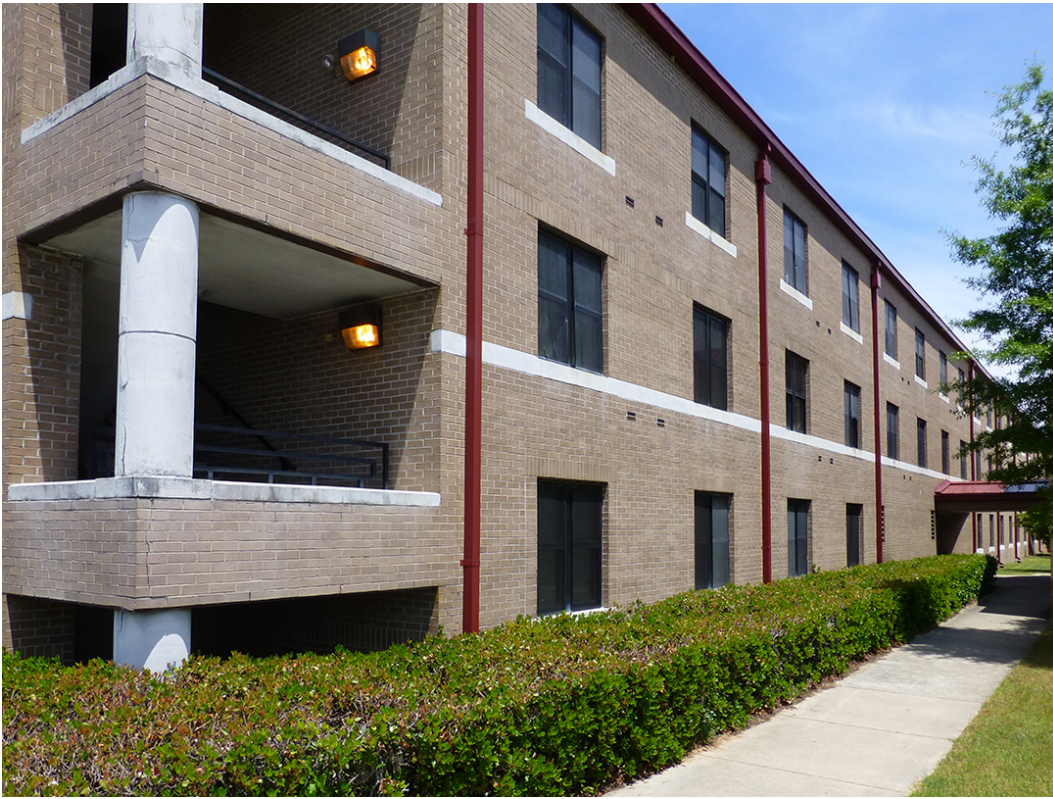
Photo 5. South side of Building 24413 at Fort Gordon, GA, showing open stair landings, precast-concrete columns, precast-concrete belt course, precast-concrete windowsills, and square window openings (ERDC-CERL, 2015).

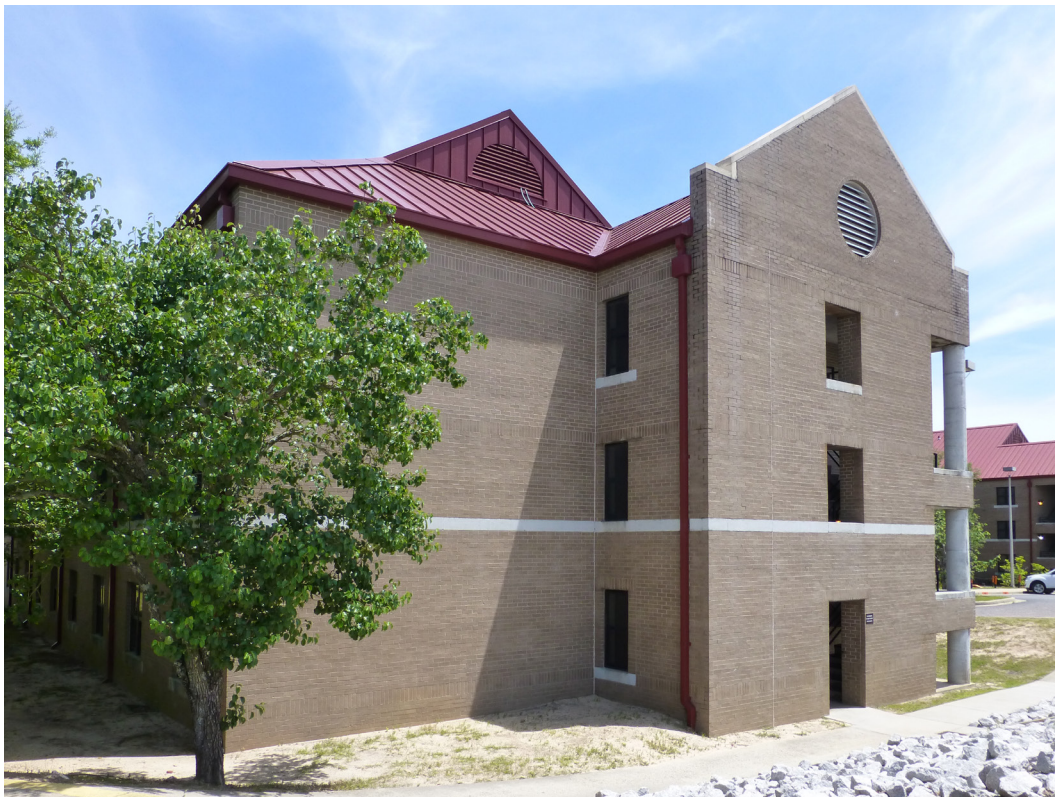
Photo 8. West side of Building 24405 at Fort Gordon, GA, showing gable end with open stair landings, precast-concrete columns, and precast-concrete belt course (ERDC-CERL, 2015).

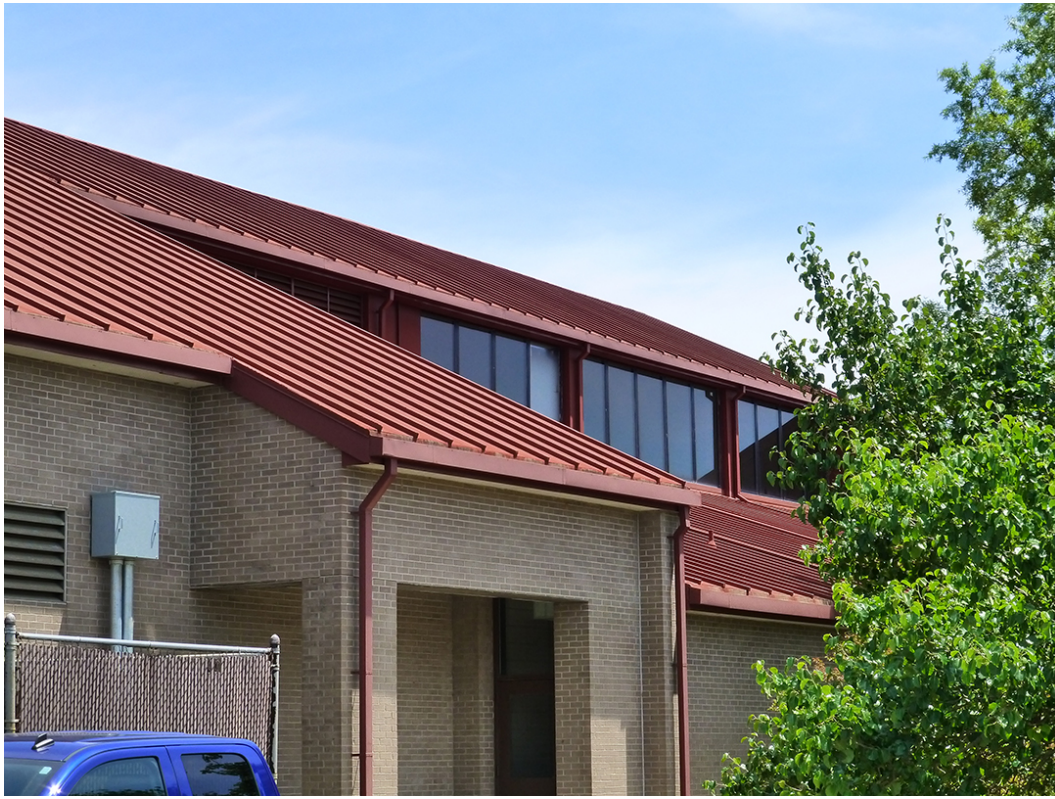
Photo 7. Detail of west side of Building 24414 at Fort Gordon, GA, showing west entrance, red metal roof, and clerestory windows (ERDC-CERL, 2015).
